HISTORIC STRUCTURE REPORT

Architectural Data Section

LINDENWALD

MARTIN VAN BUREN NATIONAL HISTORIC SITE

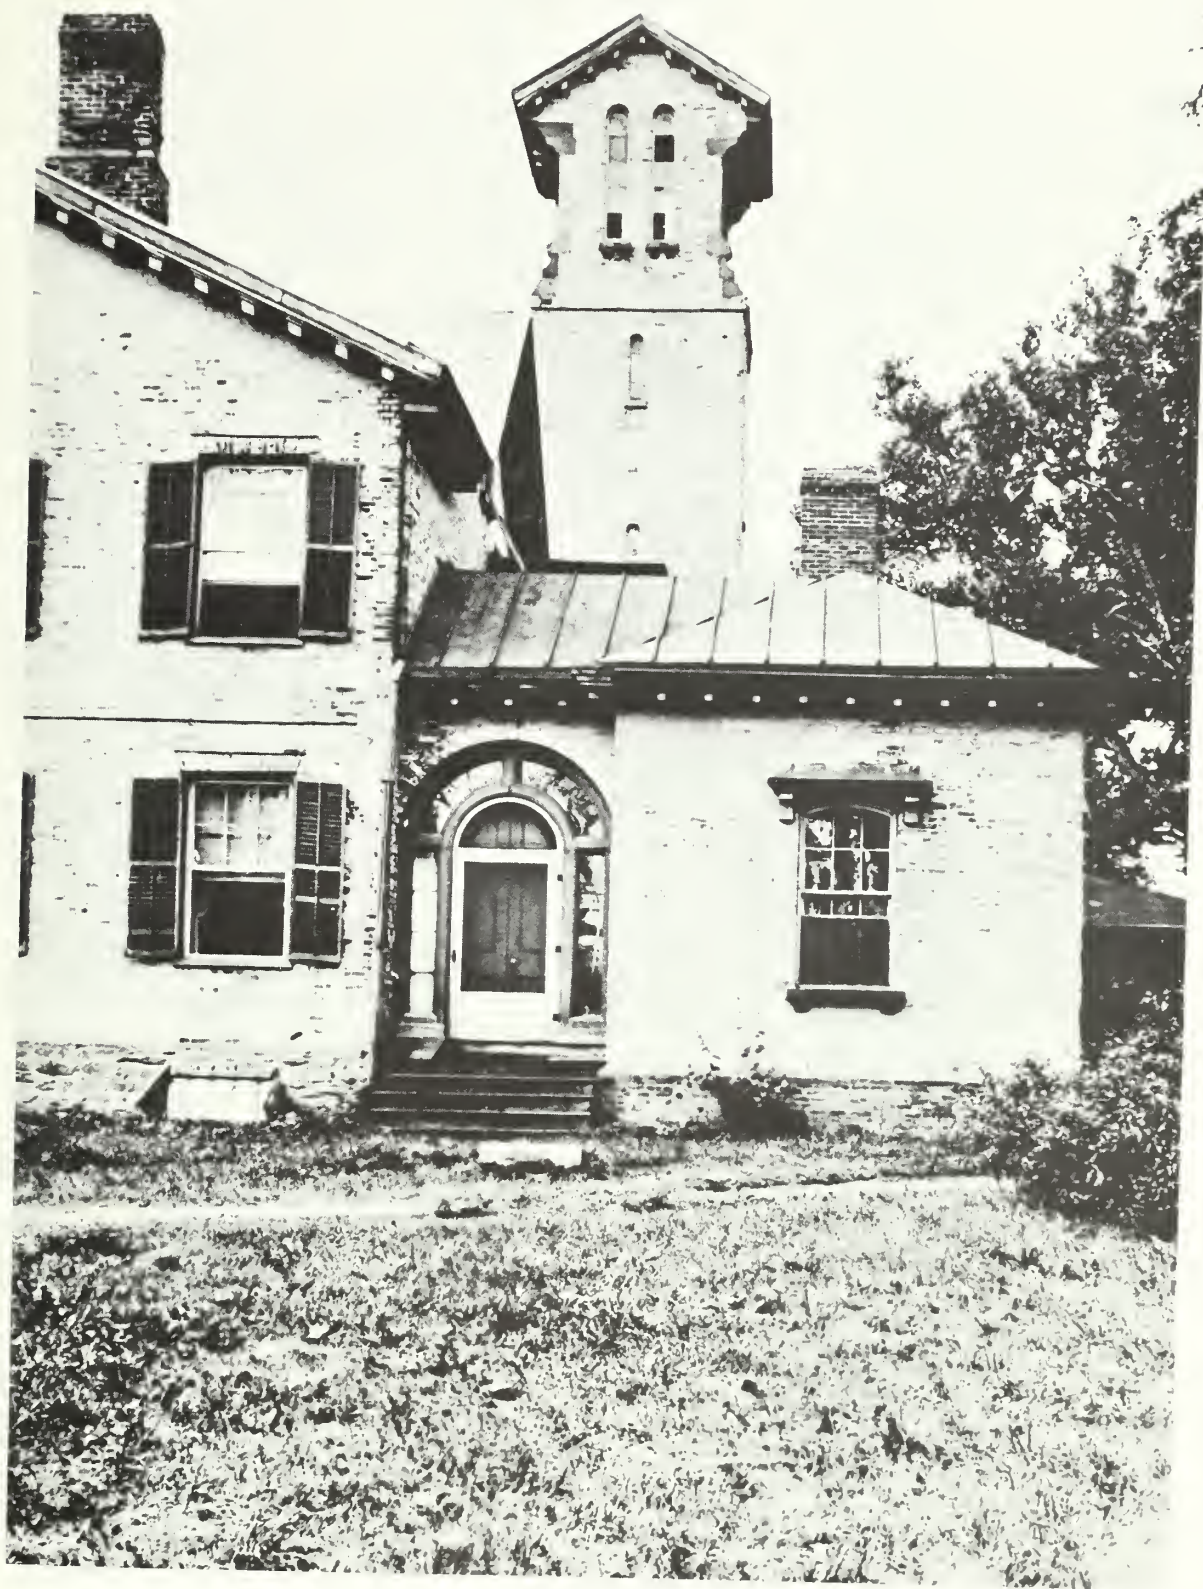
HP28. Lindenwald, West Elevation, 1936. This photograph was taken by Melvin Weig on August 3, 1936. The following details should be noted:

An early 20th century porch is attached to rooms 112 and 114.

There are modillions on the skylight cornice.

There are steps at door 112.

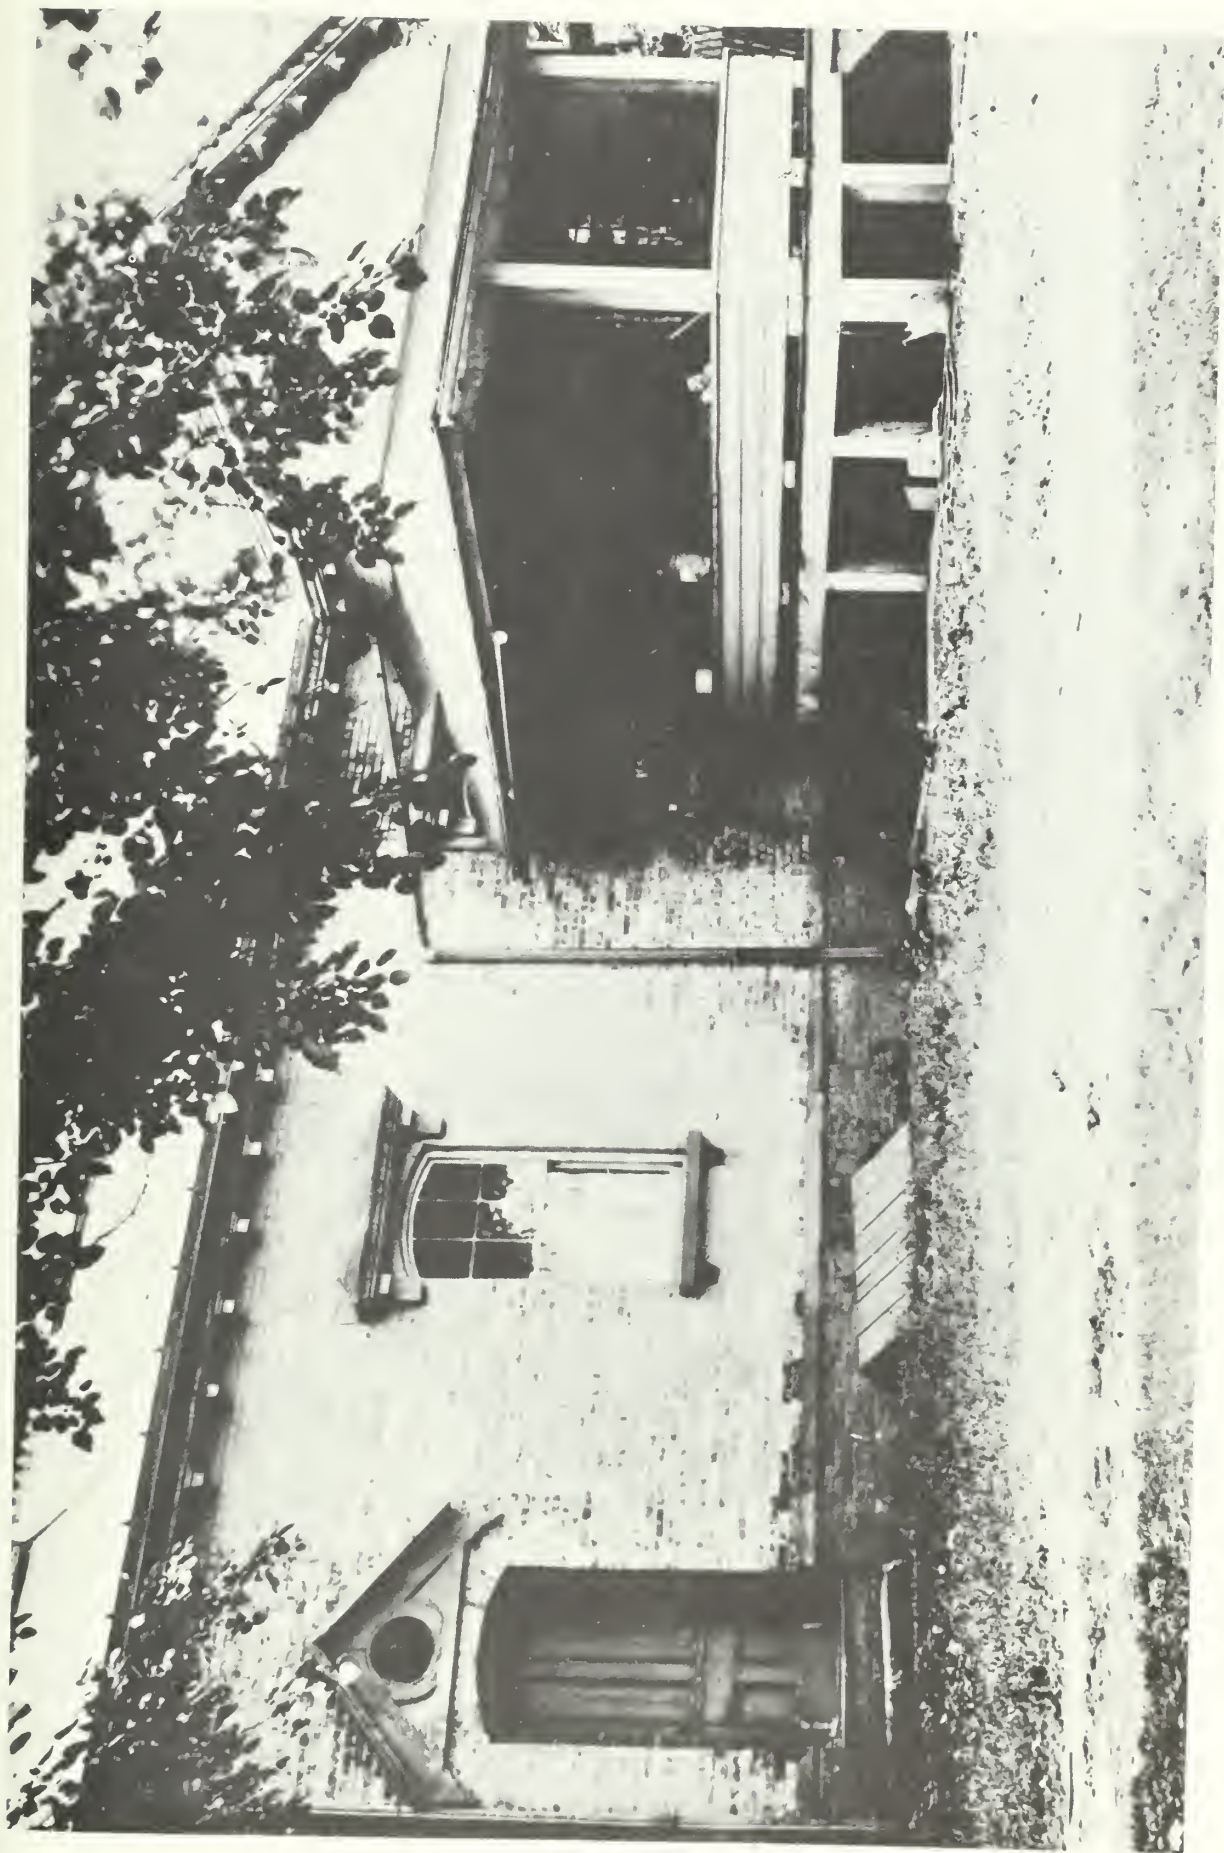
HP29. Lindenwald from the Southwest, 1936. This view was taken by
Melvin Weig on August 3, 1936. The following details should be noted:

- outbuilding in deep shade at left side of photograph
- chimneys, gutters, and roof surfaces
- paint scheme and condition
- farming equipment at right side of photograph
- clothes-drying rack

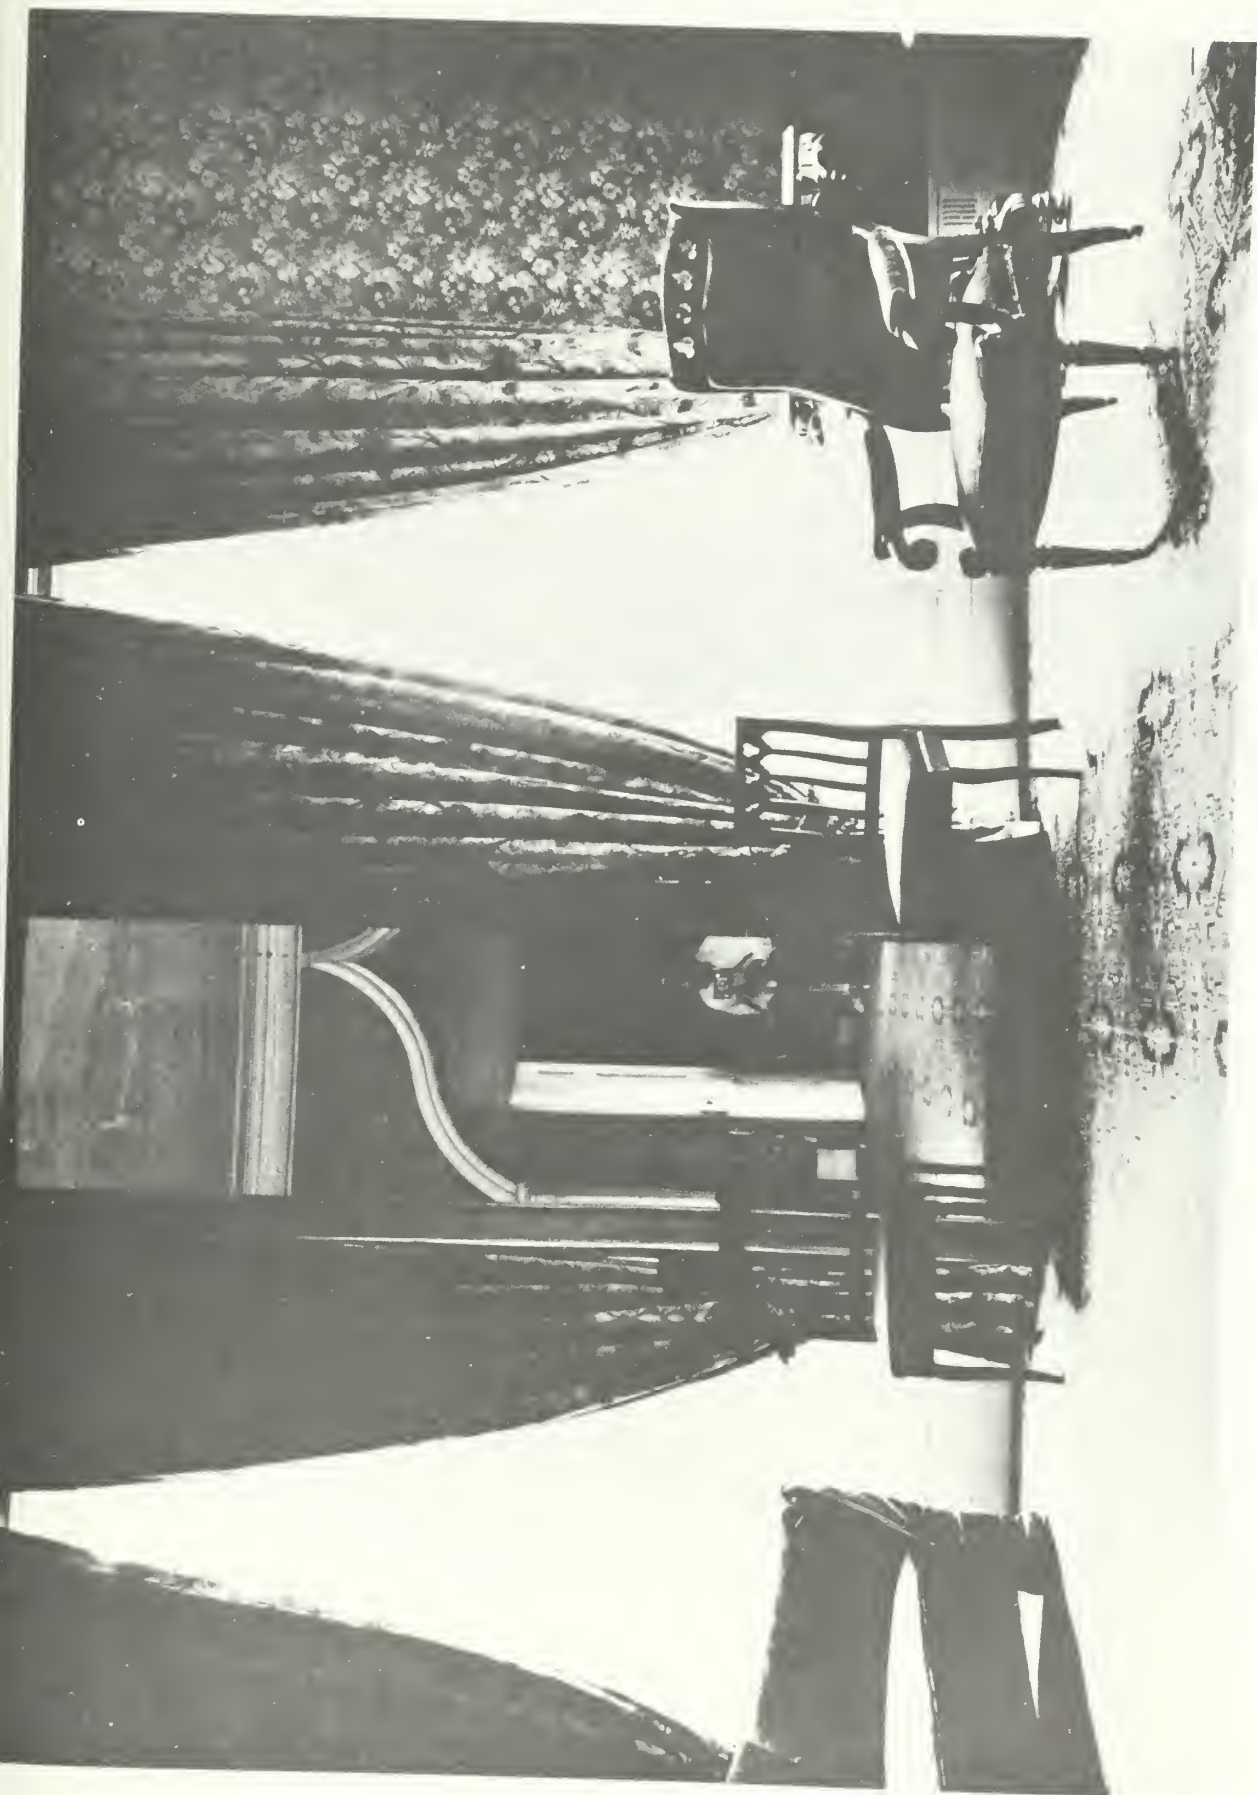
HP31. Fireplace and Part of the South Wall of Room 106, 1936. This photograph was taken by Melvin Weig on August 3, 1936. The following details should be noted:

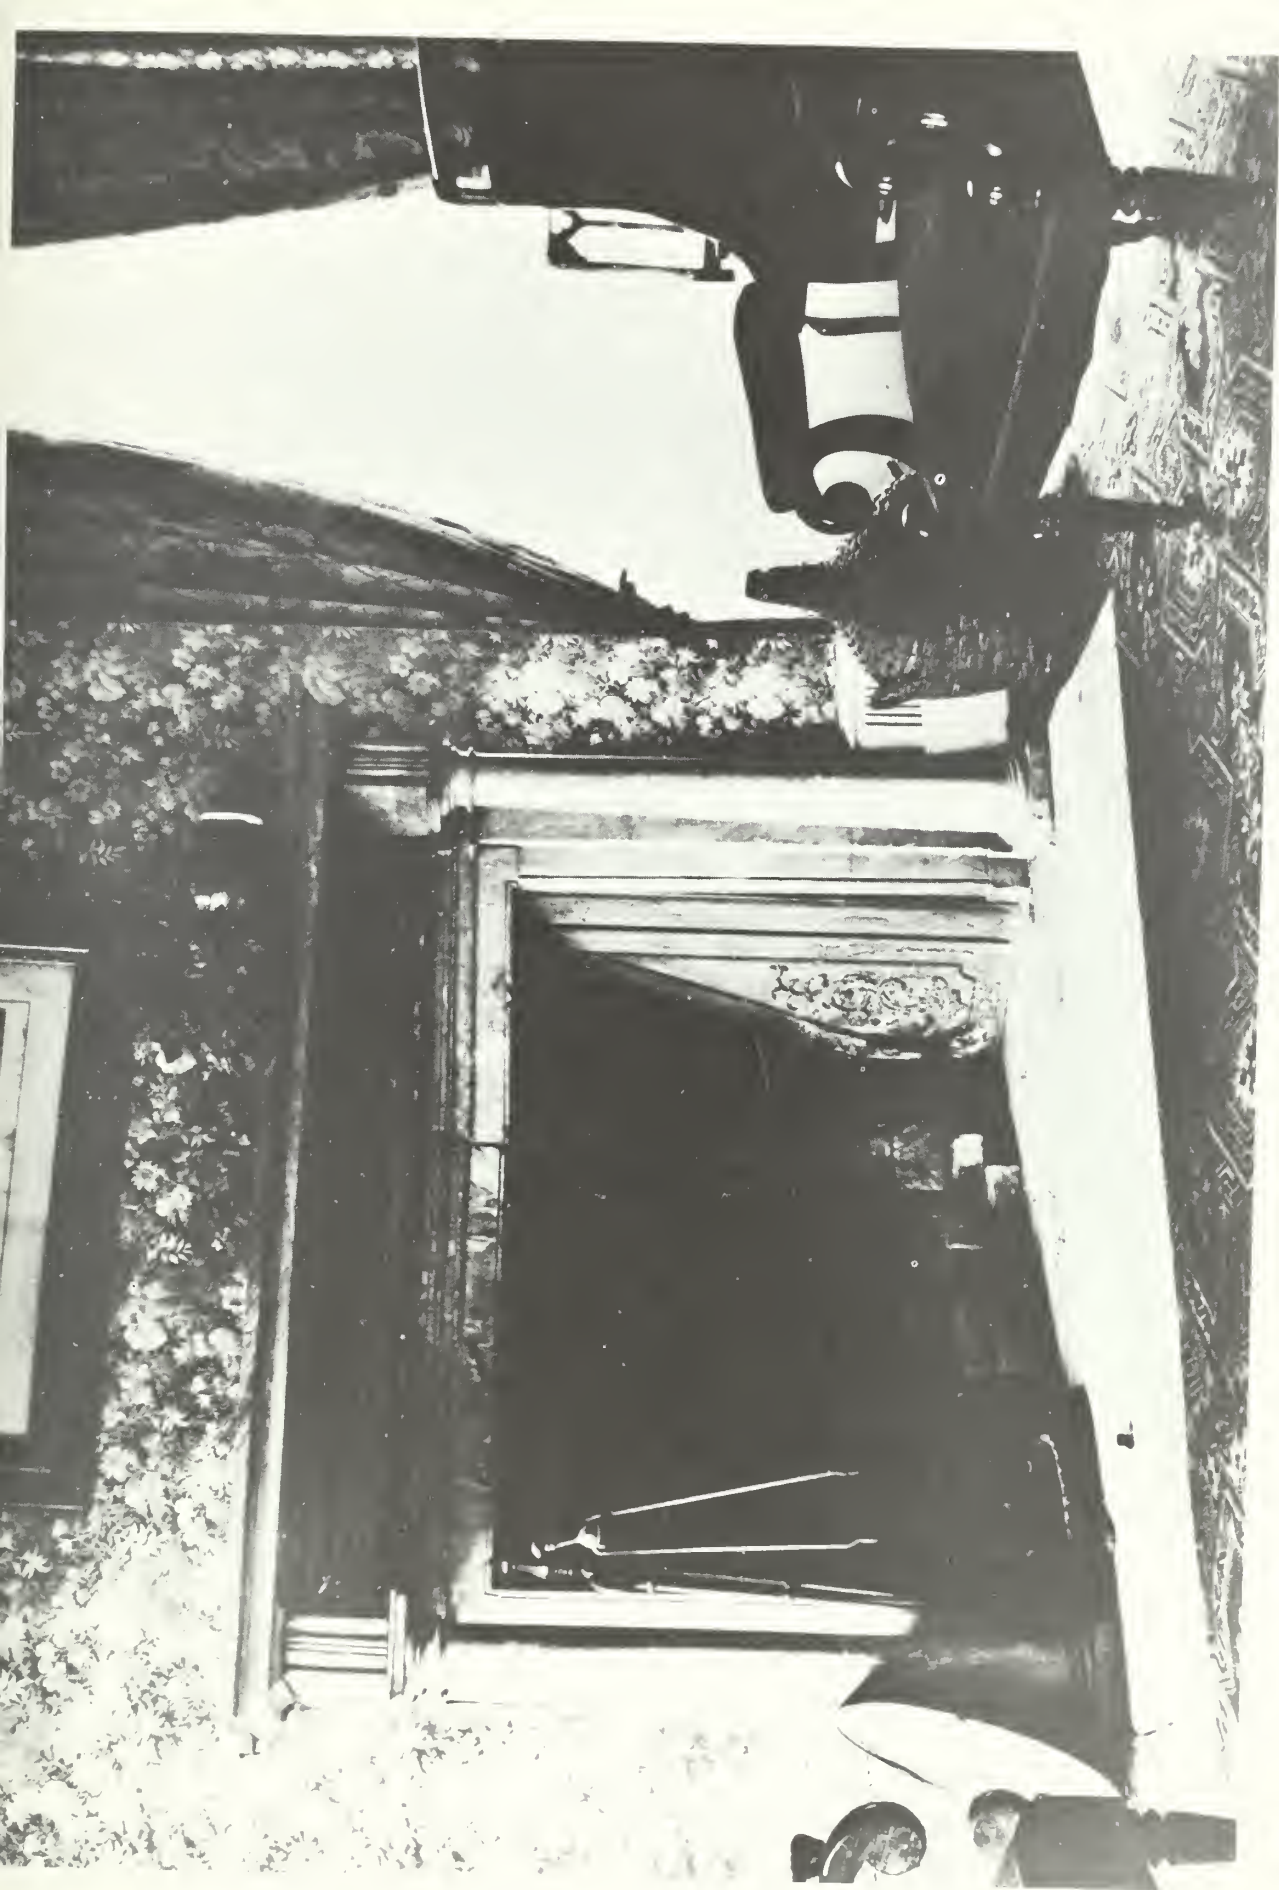
HP32. Fireplace and Part of South Wall of Room 209, 1936. This photograph was taken on August 3, 1936, by Melvin Weig. The following details should be noted:

The wallpaper is probably not historic.

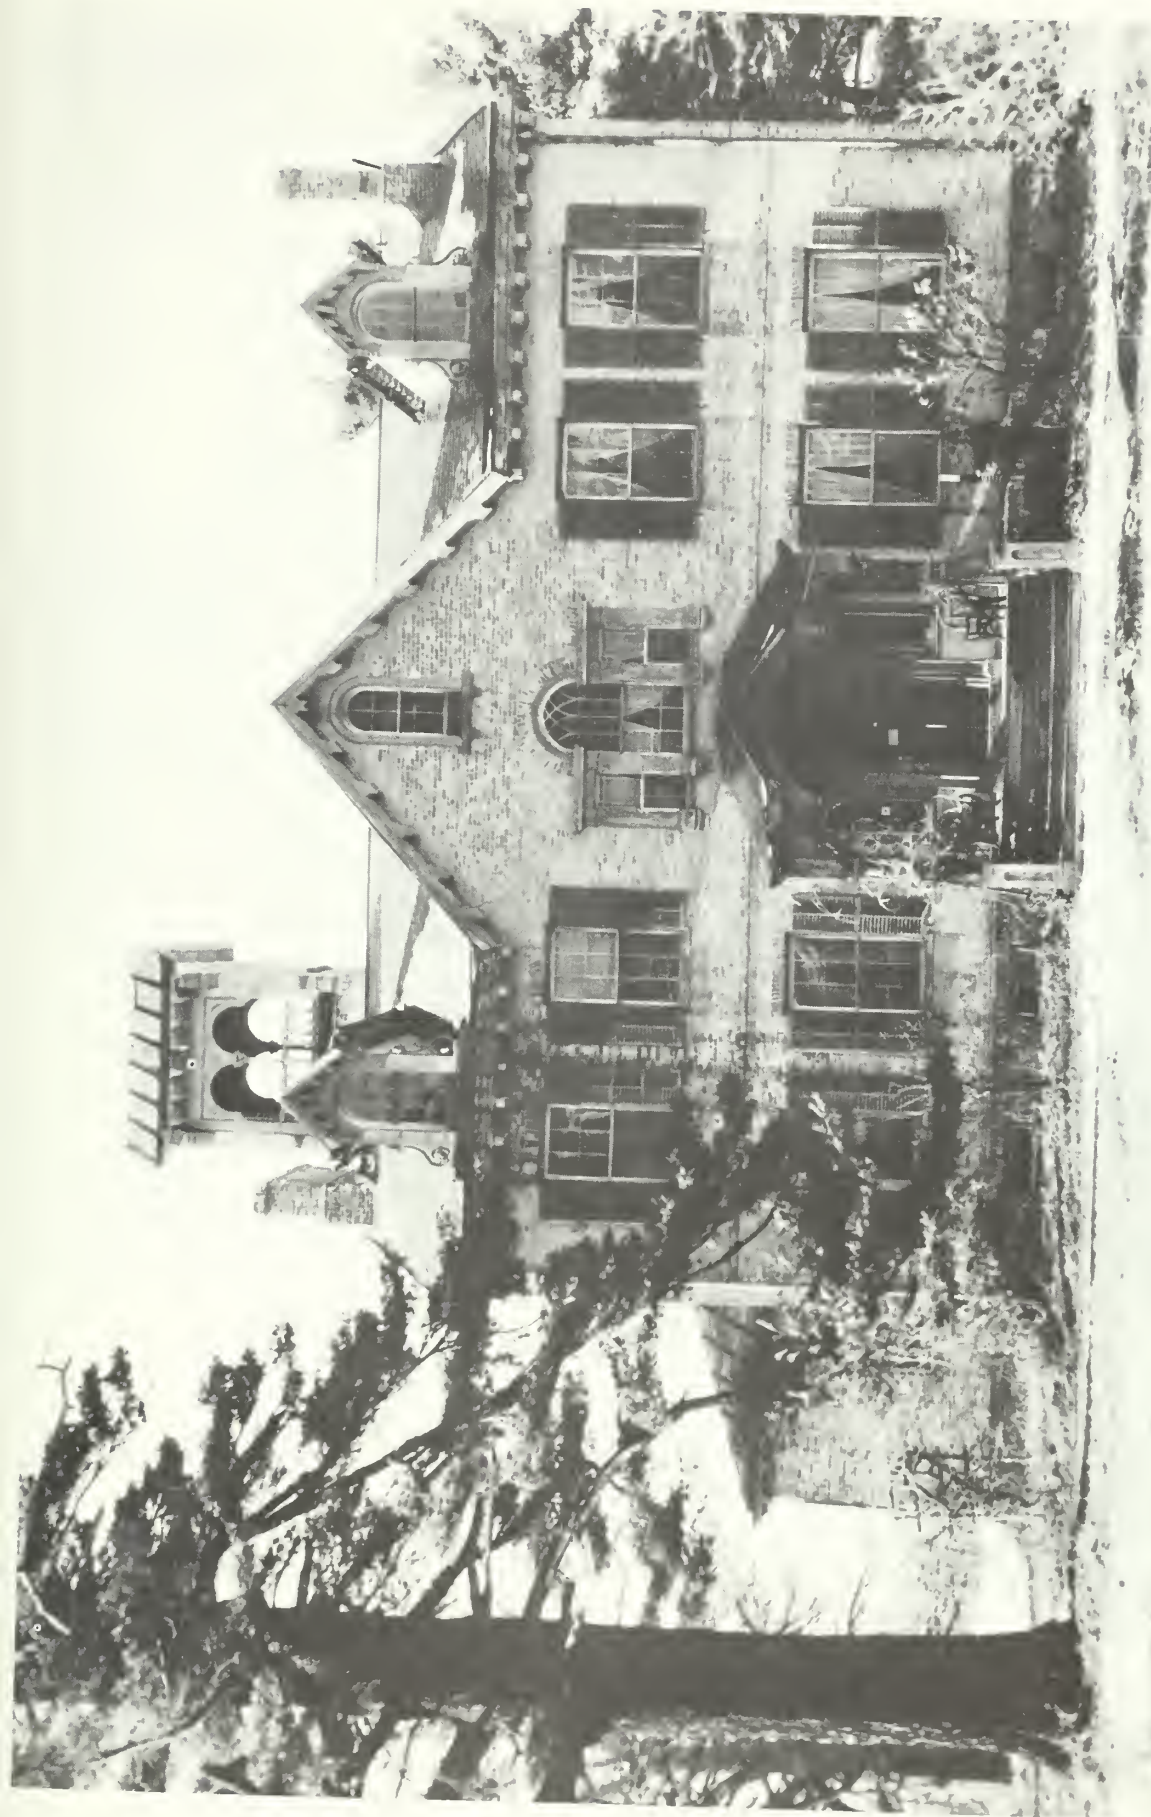
HP35. Front Door of Lindenwald (Door 101), 1937. This photograph was taken by Nelson Baldwin in January 1937. The following details should be noted:

The sash are painted a lighter tone than the brickwork. Door and window trim and the porch elements are painted a darker tone. The front door is painted an even darker tone. The porch rafters and ceiling (sheathing boards) appear to match the brickwork.

There are stuccoed areas over windows 103 and 104.

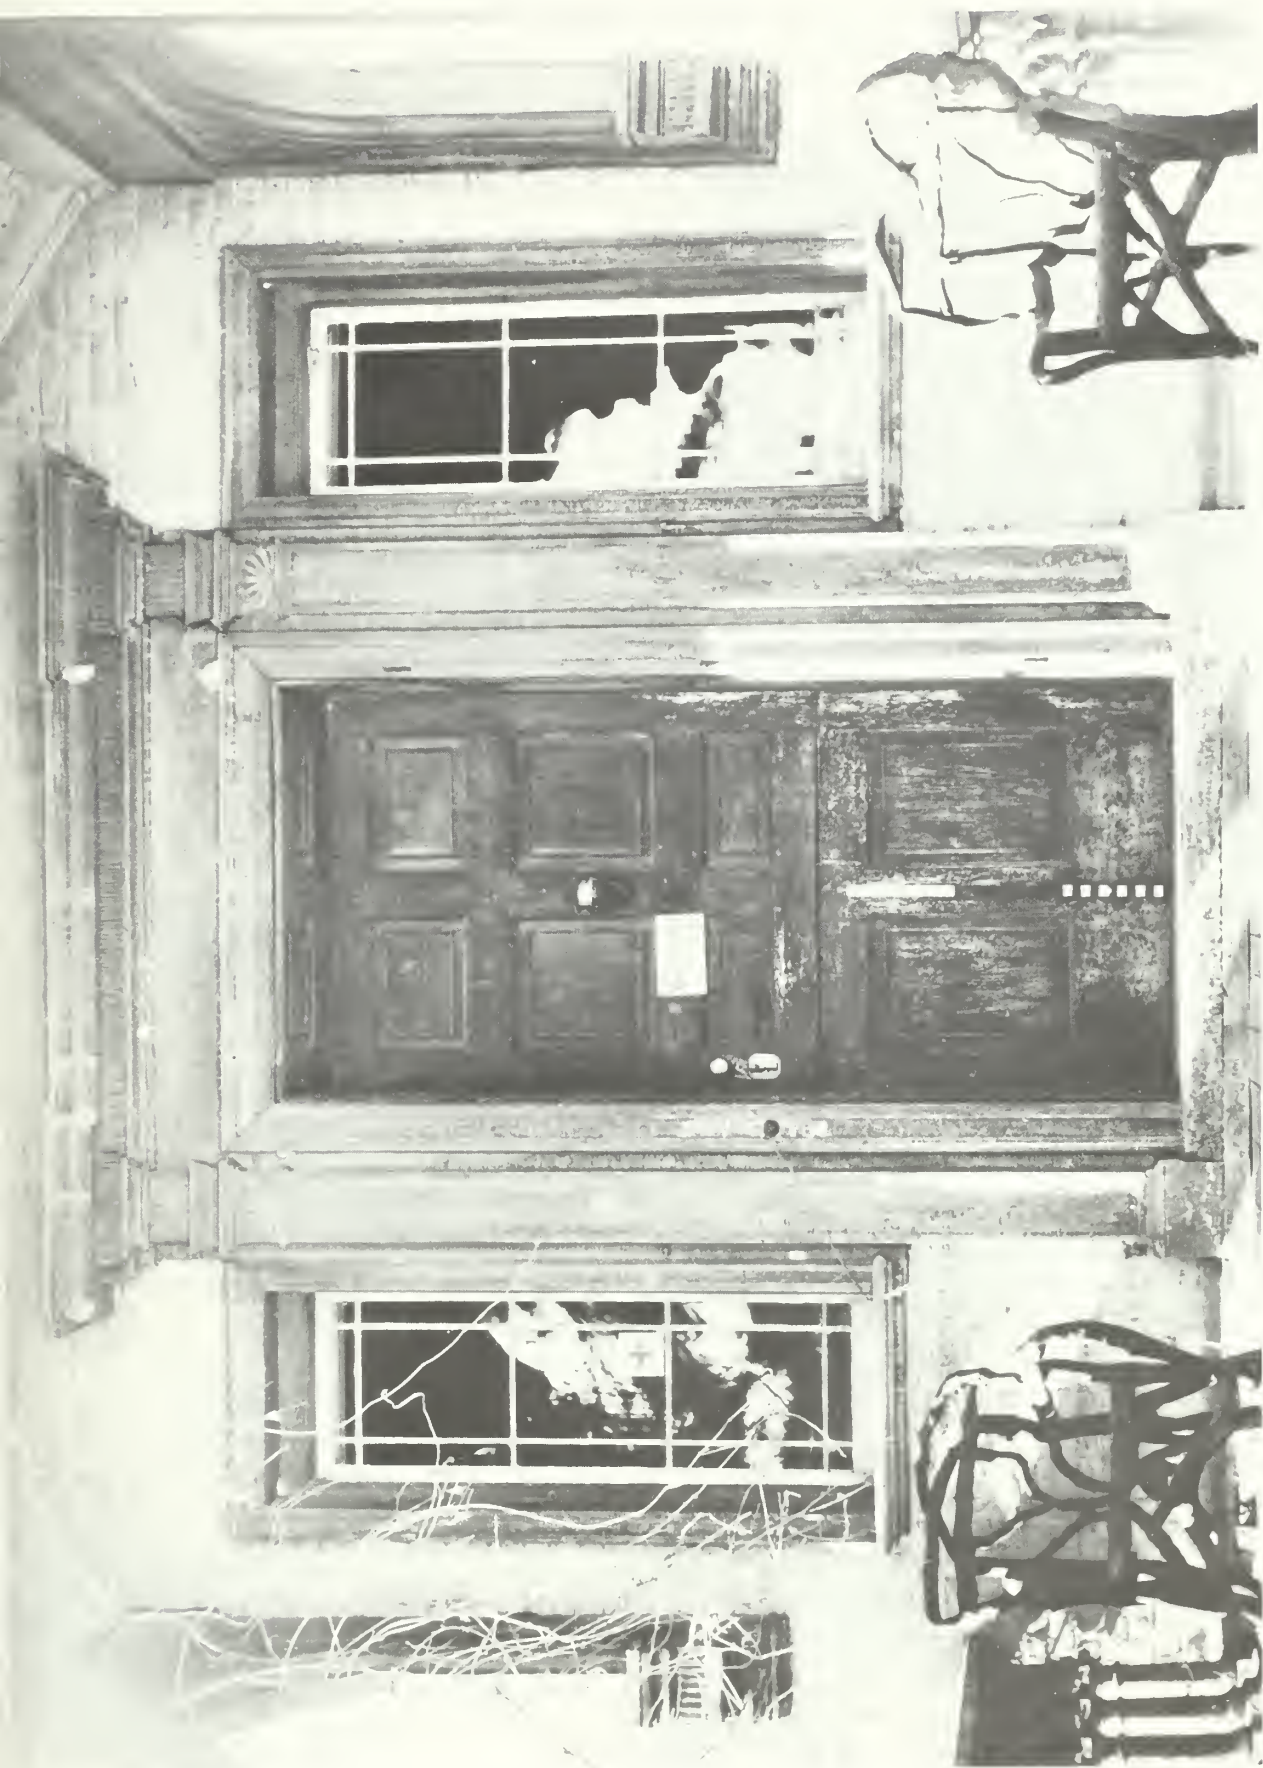
HP36. North Elevation of Lindenwald, 1937. This photograph was taken by Nelson Baldwin in January 1937. The following details should be noted:

The paint scheme is the same as in HP33.

Remnants of ferns are present at the east end of the north foundation wall.

There is a cover over window 007.

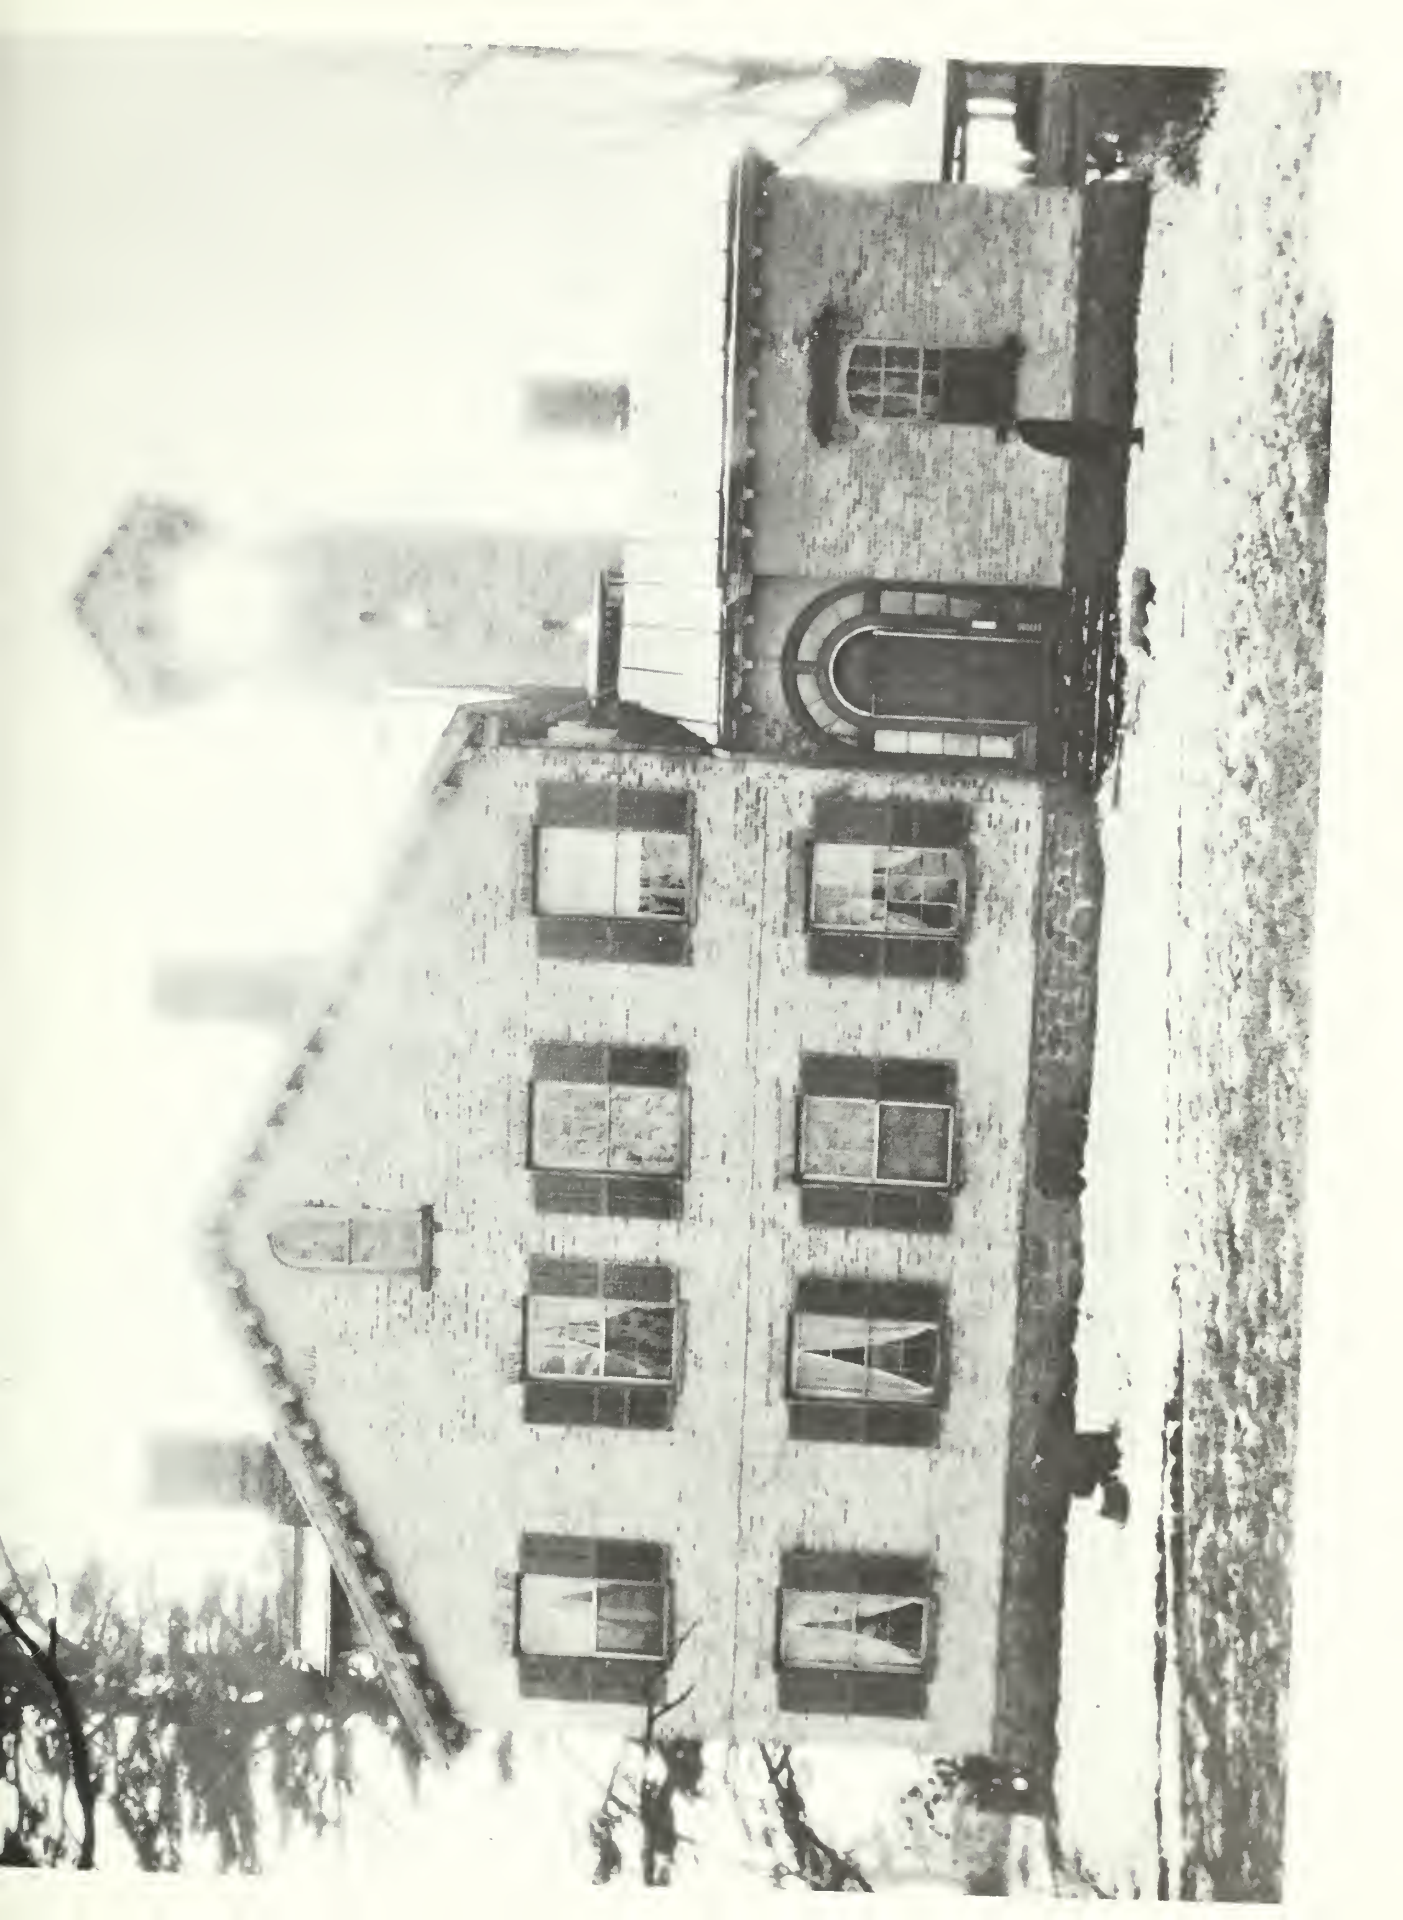
HP37. North and East Facades of Lindenwald, ca. 1942-1946. This photograph is from the Rowles Studio Collection. There is no documented date for the photograph so we must assign an approximate date based on comparisons with other photographs. The presence of an electrical supply wire, faintly visible at the left side, definitively dates the photograph after 1936. The size of the bush in the middle of the north wall suggests that the photograph was made at least 3 to 5 years after HP36 (therefore suggesting a date of ca. 1942). The hydrangea must have been pruned after 1937 and before this photograph. The advancing deterioration of several wooden elements confirms that this photograph postdates HP36 and predates HP41. The wire (probably a radio antenna) stretched between the south chimney and the north chimney in this photograph and in HP41, but not in HP34 or HP36, provides further evidence of this sequence. HP41 is conclusively dated after HP37 by the new paint on window and door frames and by the absence of dormer scrolls. DeProsse family recollections date this repainting to 1946 (W.N. Jackson, "Oral History Report," September 5, 1979). Thus, a date of ca. 1942-1946 is assigned. The evidence for the latter date is discussed in conjunction with HP41.

The chimney brick coursing matches that described in HP36.

There is a splashblock at the northeast corner.

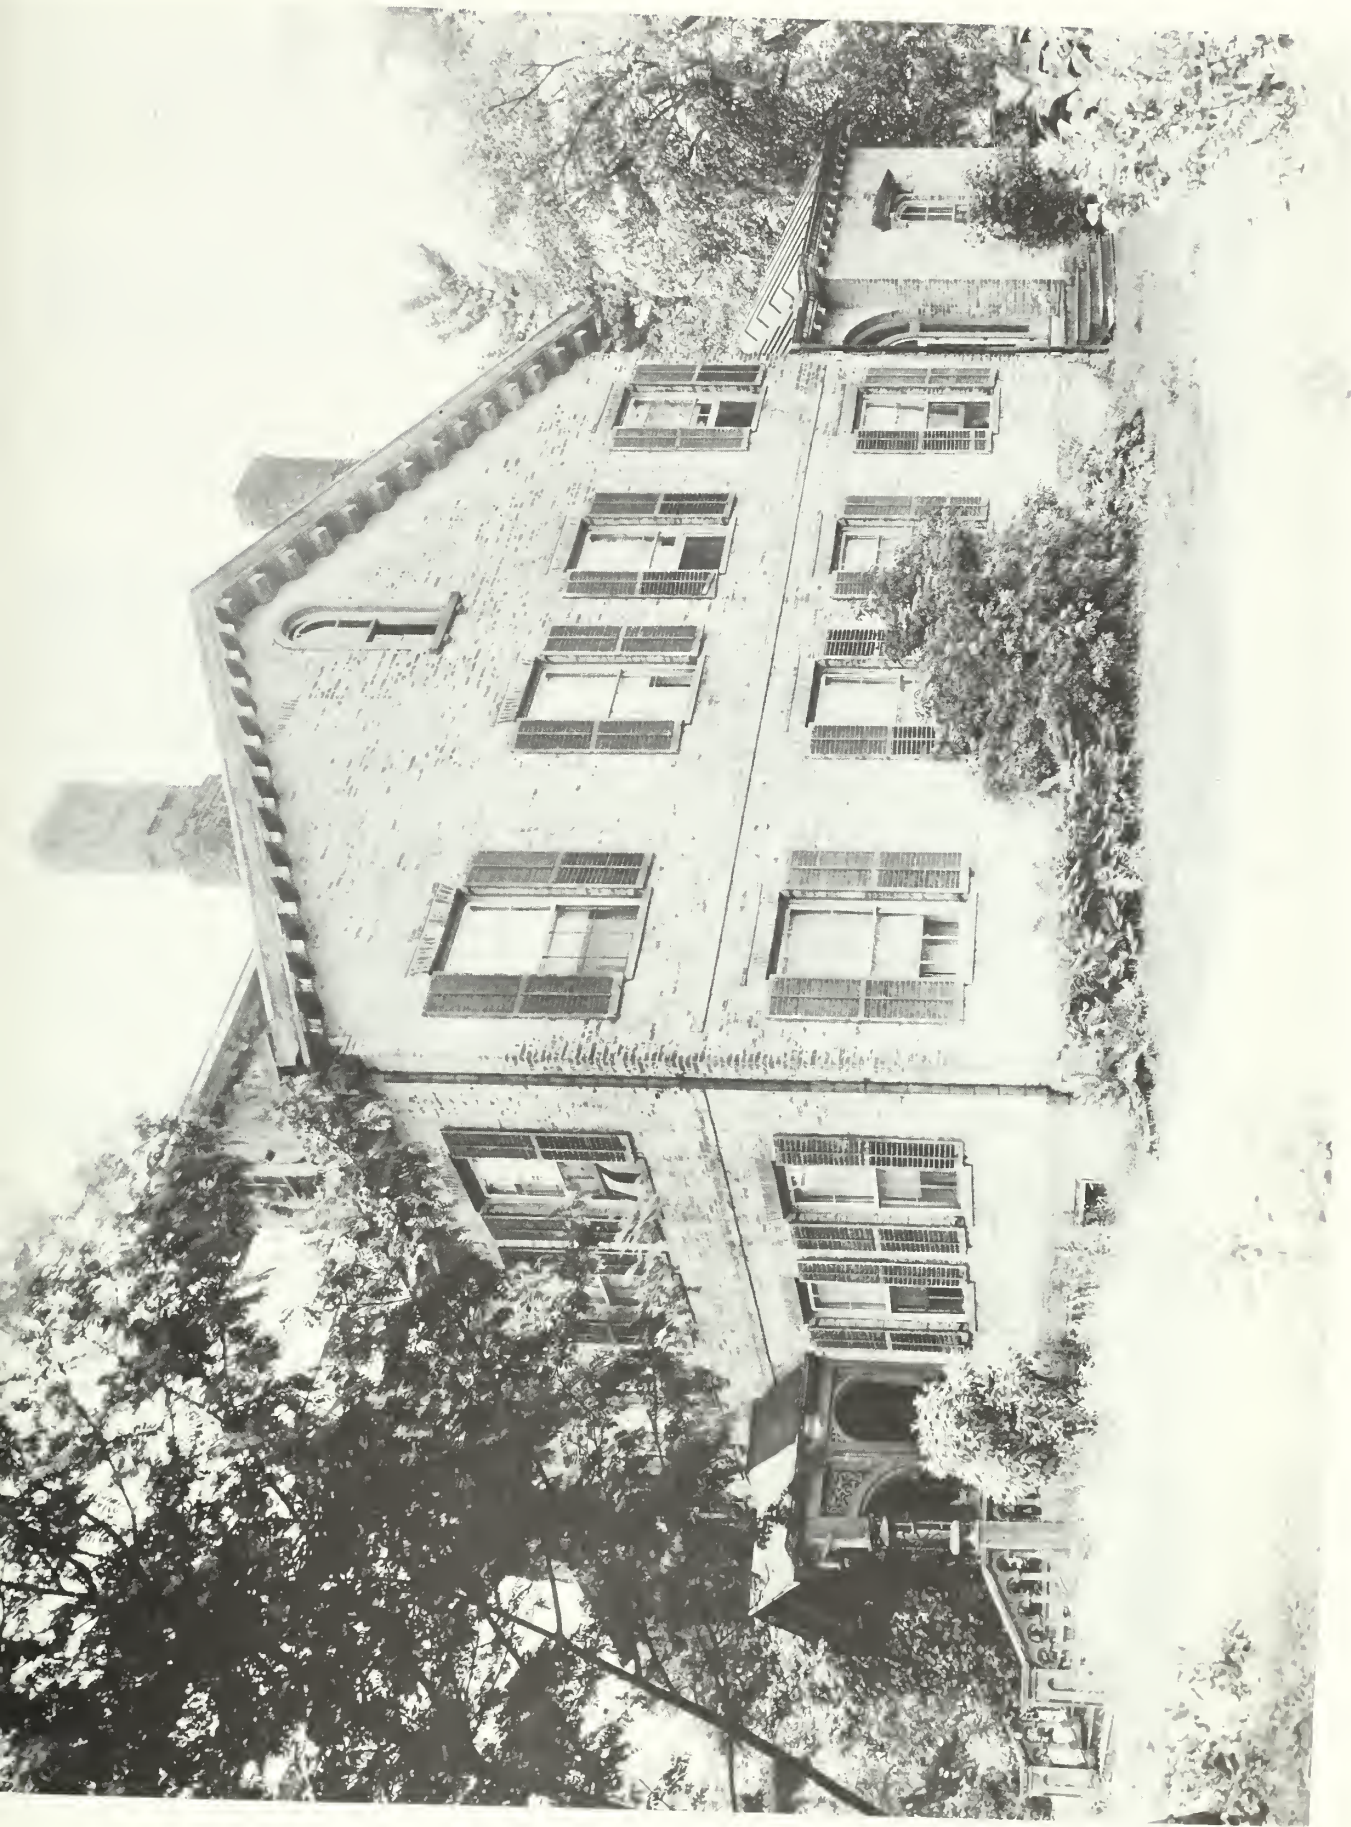
HP38. Room 104, ca. 1936-1957. This photograph and the two that follow may have been taken at the same time. All three were donated to the National Park Service by the DeProsse family. All are color photographs taken with flash. The DeProsse family association means these photographs predate the sale of Lindenwald to Ken Campbell in 1957. The identical positions of the black object (statuette) and chairs in HP39 and HP40 suggest that they were taken during the same session and, by extension, suggests that HP38 was also taken at the same time. The presence of an electrical convenience outlet in HP40 and an electric lamp in HP39 positively dates the photographs after the installation of electricity, ca. 1936. DeProsse family recollections date these photographs to the 1930s. The following details should be noted:

carpeting (Red-orange color is reported by DeProsse family to be incorrect rendition--true color is green.)

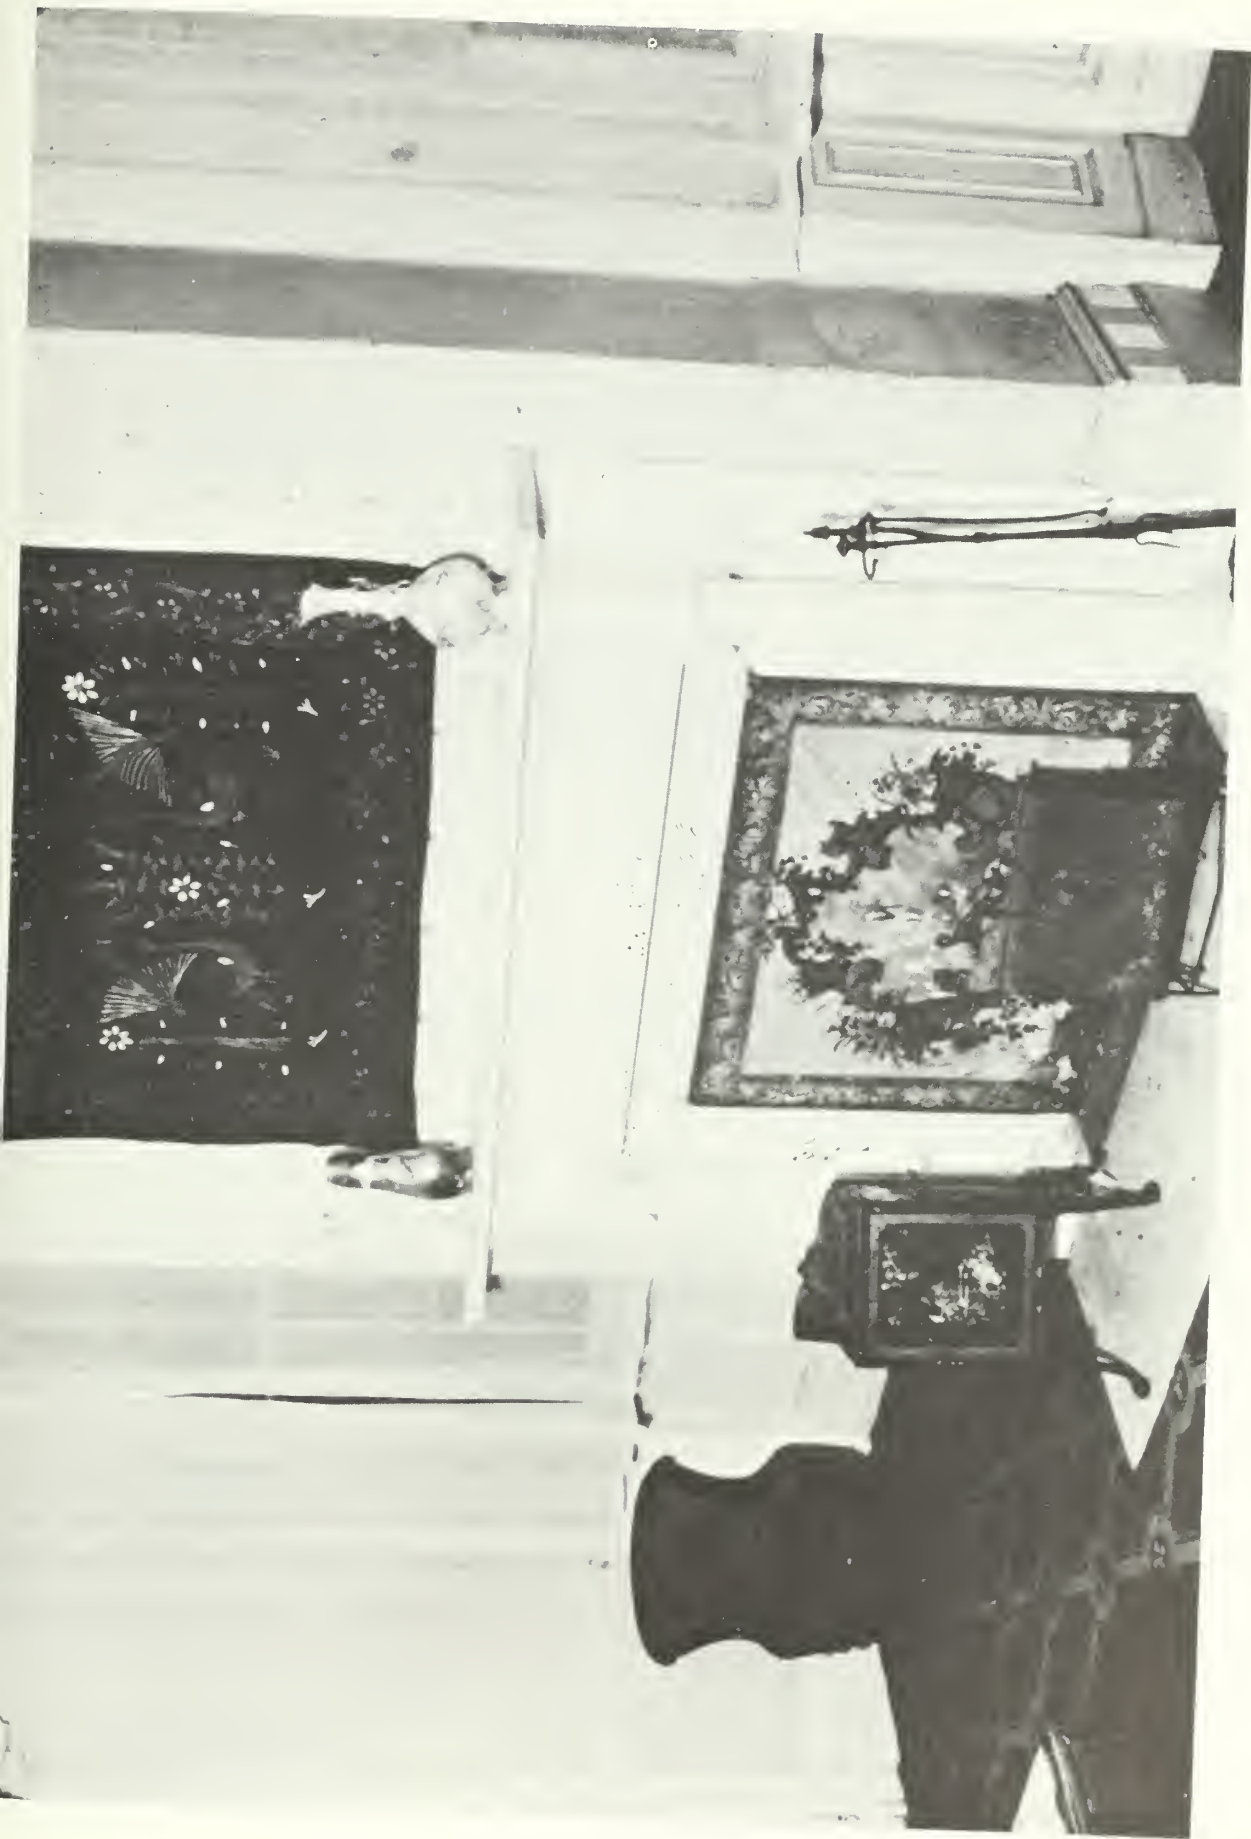
HP39. Room 106, ca. 1936-1957. This photograph is associated with HP38 and HP40 and assigned a date of ca. 1936-1957 on the basis of circumstantial evidence presented with HP38. The following details should be noted:
